<b>PROJECT</b>	Precast Concrete Plant – Septic & Sewage Units
<b>DATE</b>	July 2006
<b>CUSTOMER</b>	Fairfield Precast Concrete
<b>INDUSTRY</b>	Precast/Prestressed
<b>LOCATION</b>	Fairfield, Iowa
<b>PRODUCTS</b>	Penetron Admix®

**CASE SUMMARY**

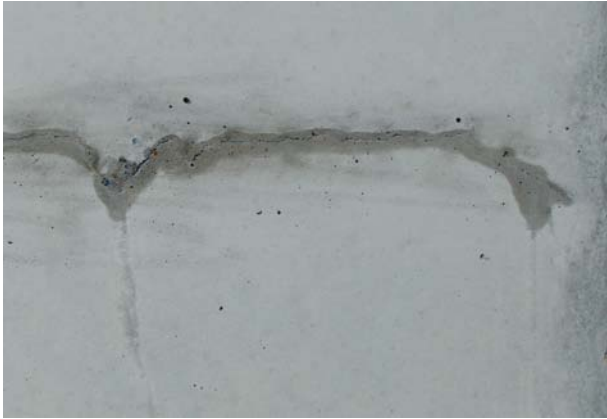
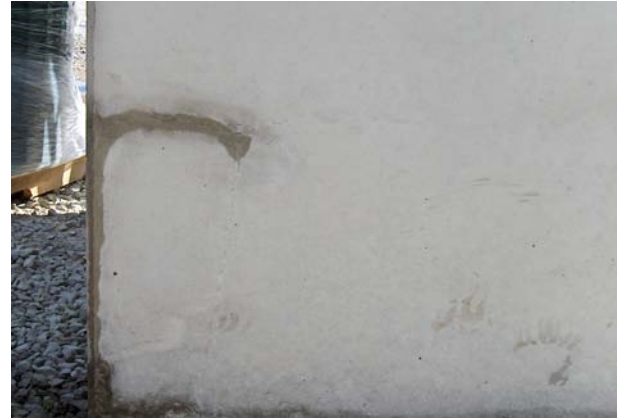
**DAY 1: Leaks appear as the tank is filled**

Initially, while there was no noticeable drop in the water level, a number of leaks became apparent, showing themselves as continuous, dripping leaks. After three days the leaks had been reduced to a slow seepage with moisture creeping down the face of the tank 3-4 inches before evaporating. At this time, crystals were plainly visible as they began to fill in the cracks. After seven days all leaks had stopped completely as crystal growth continued in the cracks, self-healing them until there was no moisture. The customer also noted that the shrinkage cracks that were also appearing in the precast concrete lids of these tanks had also lessened through the use of Penetron Admix®.

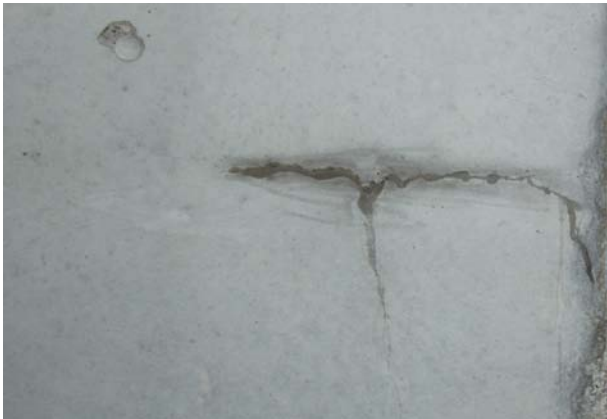
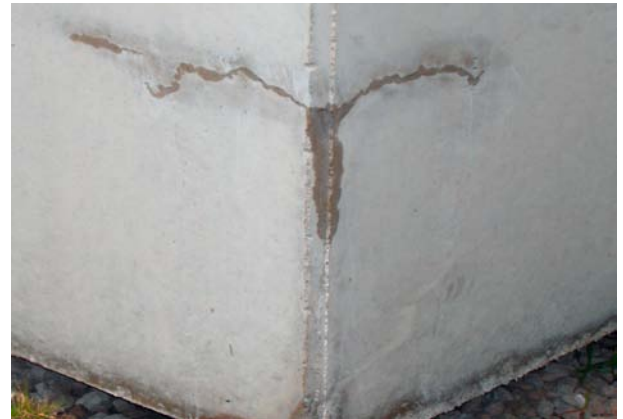
**DAY 3: Crystals begin to grow filling the cracks**

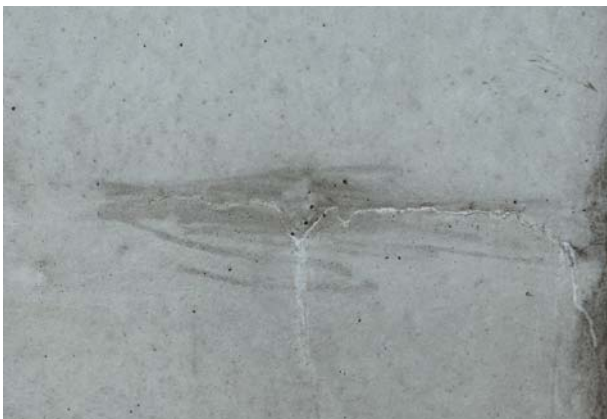
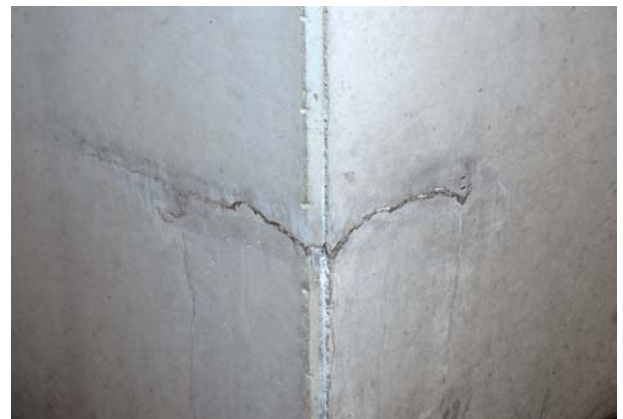
**DAY 7: All cracks have self-healed and leaks completely stopped**
